MISCELLANEOUS PAPER C-78-16

TESTS OF BRICK-VENEER WALLS AND CLOSURES FOR RESISTANCE TO FLOODWATERS

Carl E. Pace

Concrete Laboratory

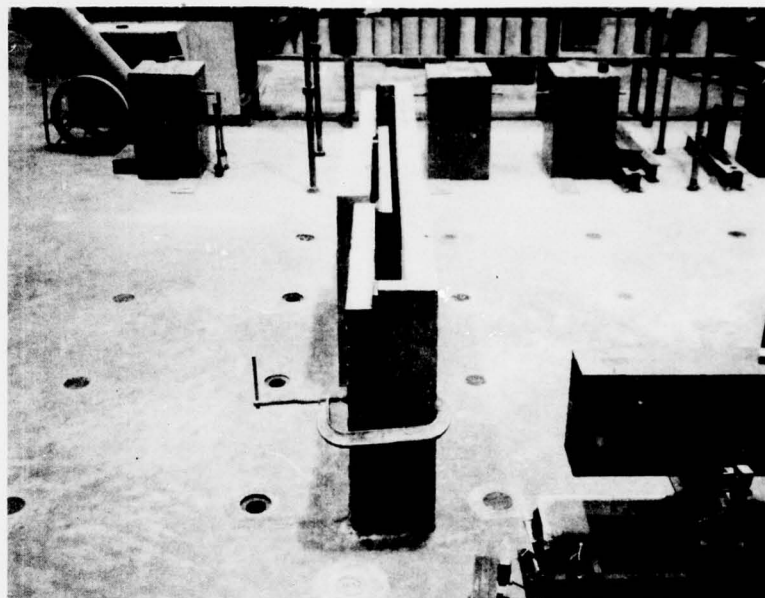
Figure 5. View 2 - bulkhead to contain water against the wall and closure

- d. A bulkhead constructed of plywood and 2 x 4's (Figures 4 and 5) was placed across the walls and closures and sealed to the floor and to the walls' outer edges to contain the water. Different wall coatings and closure constructions were tested with this system.

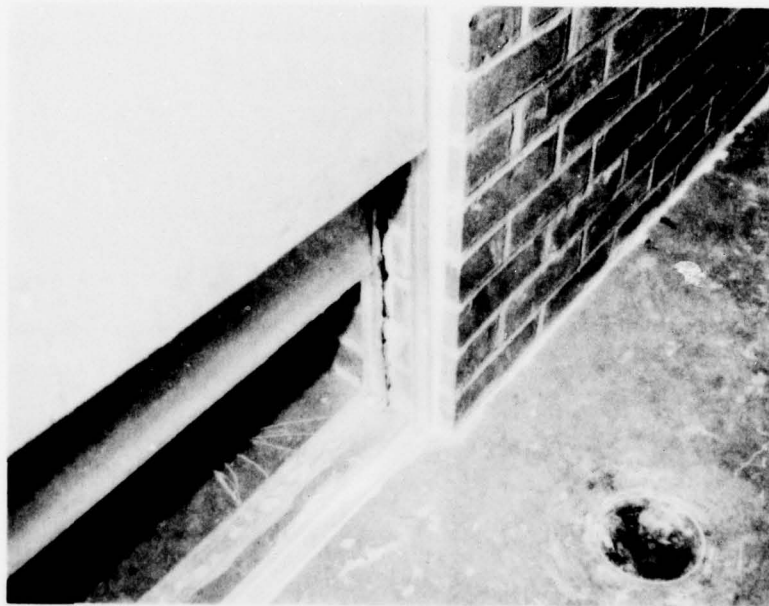
Figure 15. Two sheets of plywood used to form a closure

- d. Channels were attached to the brick sides of the door opening and angles were fixed at the base to hold a piece of plastic-coated plywood as a closure (Figure 14). Two sheets of plywood (Figure 15) were used in order to check the penetration of water to the barrier, along it and out between the two layers of brick at the closure into the space between the two sheets of plywood. In other words, we knew the closure should be on the opposite side of the water barrier from where the water was applied but the second sheet of plywood was placed on the same side of the barrier as the water was applied. The criticalness of the closure location could be checked by how fast the space between the two sheets of plywood filled up with water. The summary of tests on Wall 2 is as follows:
